## Case study 1: Green engineering

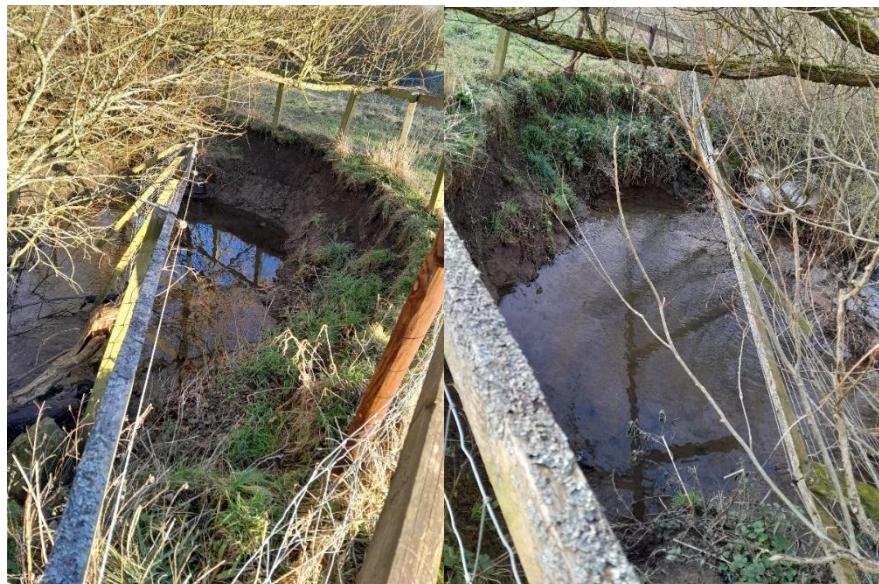
Before:

We worked with an equine livery yard near Lanchester, County Durham. Two water bodies run through the site, Smallhope Burn and Stocksley Burn. We installed green engineering bank repairs on a section of Smallhope Burn to prevent erosion. 5-meter section of Smallhope Burn was experiencing severe erosion, with a large amount of sediment entering watercourse. Landowner has already replaced fencing as previous fence was undercut by erosion and new fence was beginning to be undercut.

We constructed a green engineering bank repair, using coir matting to prevent soil loss and brash bundles. The bank repair was constructed by a team of 4 volunteers and 3 WRT staff for two 3-hour sessions. Volunteers also planted willow pegs in other areas of bank erosion and deposition to stabilise the banks and prevent sediment loss.
